Case Report

Application of a Titanium Screw for the Hemorrhage from the Bone Channel during the Lateral Window Technique: A Technical Note

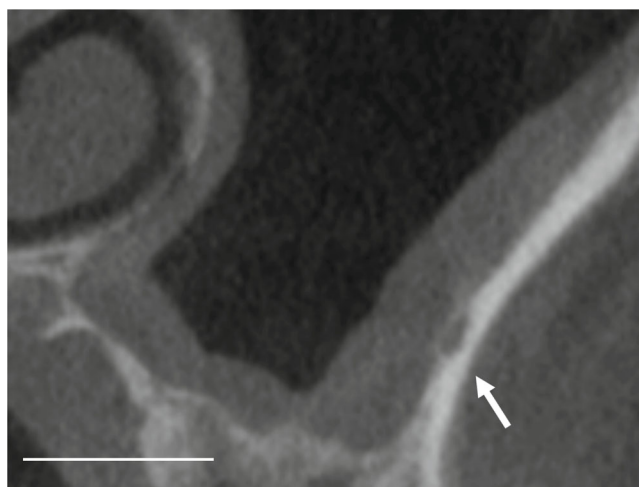
FIGURE 1: Coronal view of the base of the maxillary sinus in region of tooth #26. The posterior superior alveolar artery (arrow) is observed along the inner aspect of the cortical bone of the sinus wall. (White bar indicates 10 mm).

A computed tomography (CT) scan was performed preoperatively to evaluate the sinus condition and locate the intraosseous vessels (Figure 1). Sinus floor elevation via the lateral approach was conducted using a piezoelectric diamond insert OT5A (Mectron s.p.a., Carasco, Italy) [1, 2]. Sinus antrotomy was safely performed, and membrane elevation was done thereafter. During the elevation, pulsatile and profuse hemorrhage suddenly occurred, seemingly from a relatively large branch and not from small branch ramifications of the artery. A branch located just internal to the wall was suspected to be torn during the detachment of the sinus membrane from the inner aspect of the wall.

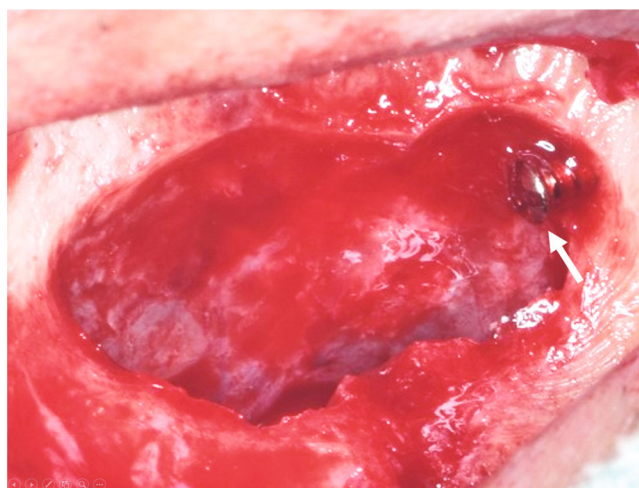
FIGURE 2: Titanium screw insert for hemostasis. Complete occlusion of the bone channel of the posterior superior alveolar artery achieved by the screw (arrow). The sinus membrane was sufficiently elevated without perforation, and desirable space was created for bone grafting. After achieving hemostasis, bone grafting was performed using Bio-Oss®, as planned.

channel. The severity of hemorrhage reduced, but complete hemostasis could not be achieved. Then, the idea of local vessel occlusion emerged. A sterile gutta percha point #100 was provisionally inserted proximally into the bone channel as deep as possible, and complete hemostasis was achieved. Convinced that physical occlusion was effective, the gutta percha point was replaced with a titanium screw (Le Forte System screw, diameter: 1.4 mm, length: 6.0 mm; Jeil Medical Corp., Seoul, Korea; Figure 2). Complete and definite hemostasis was achieved. Artificial bone grafting (Bio-Oss®, Geistlich Biomaterials, Wolhusen, Switzerland) was then performed as planned (Figure 3) [7]. Five months later, the screw was removed without any complications (Figure 4), and the implant was placed.

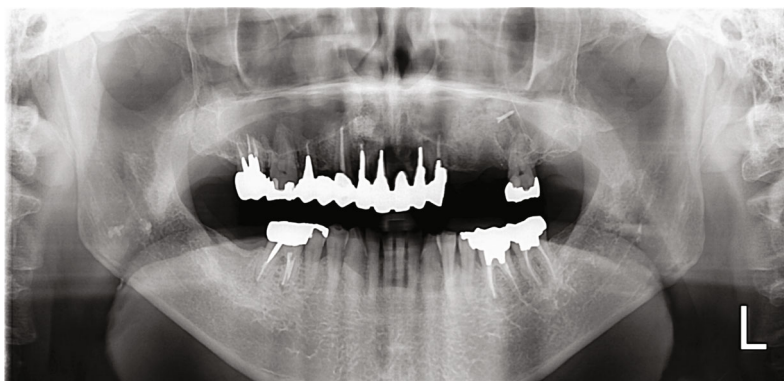
FIGURE 3: Orthopantomograph immediately after the placement of the titanium screw into the bone channel. In the upper region of tooth #27, the titanium screw is seen with the tip facing distal direction. Sufficient volume of bone grafting material is seen, as well.

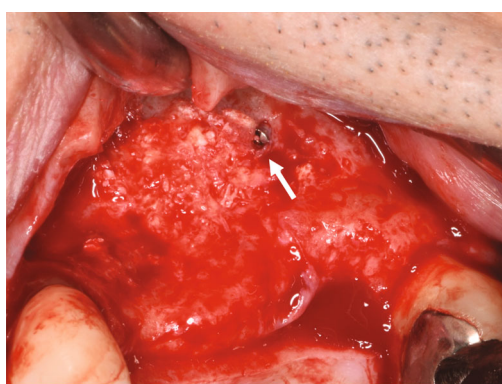
FIGURE 4: Post-operative condition five months after channel occlusion using the titanium screw. The screw (arrow) is still in place, and sufficient bone augmentation has been achieved. It could easily be removed later, without any complication, followed by implant placement.
